Number Eight!

by Tom Endy

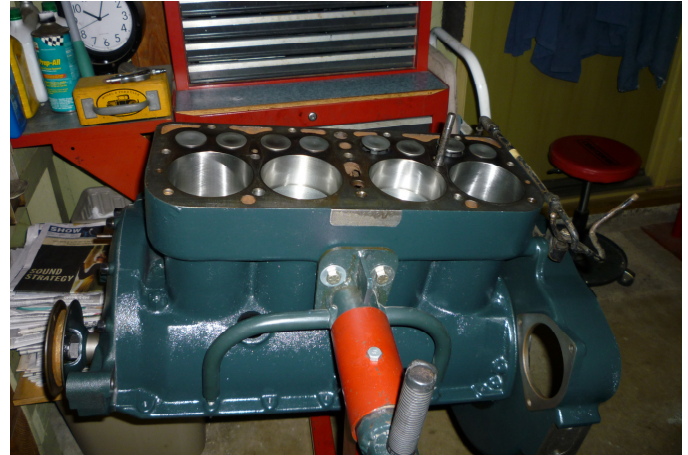
The #8 stud sits right next the narrow area between the #3 and #4 cylinders where the head gasket is very narrow and susceptible to blowing. The area between #3 and #4 cylinders is the most common area for a head gasket to blow even when there is proper torque on the stud. Removing the nut at #8, or running without the spacing of the clamp only adds to the possibility of blowing a head gasket and warping the head.

The #8 stud sits right next to the narrow area between #3 and #4 cylinder.

The best solution is to remove the clamp completely from the armored cable and install a spacer under the nut at the #8 stud to properly space it. Torque all the head bolts down to the proper specification in sequence, and don't fool with them when out on the road. The #8 stud can also be replaced with a standard length stud as used in the other stud positions.

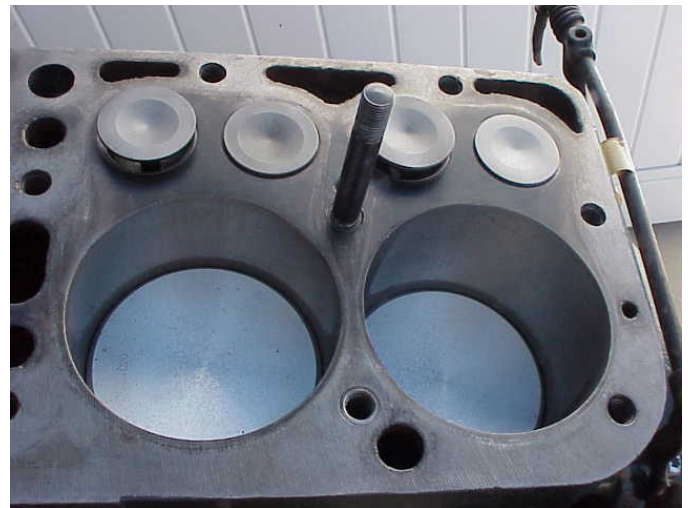
The area between #3 and #4 cylinder is a common place for a blown head gasket. The #8 stud sits right next to the area.
