Steering Column Support

by Tom Endy

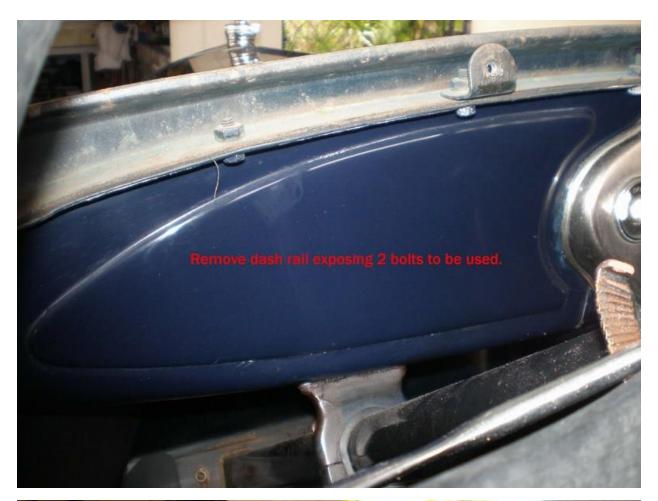
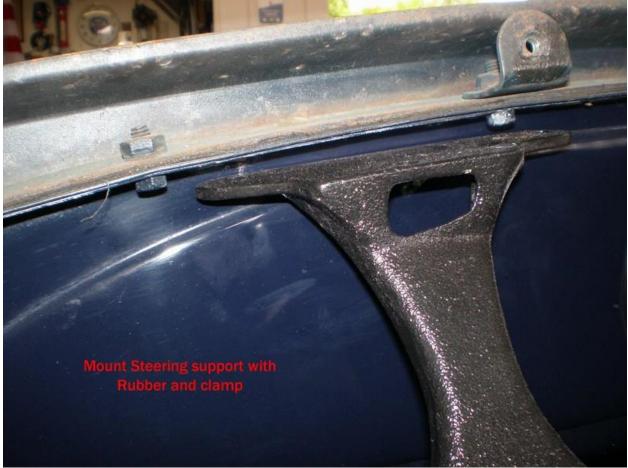
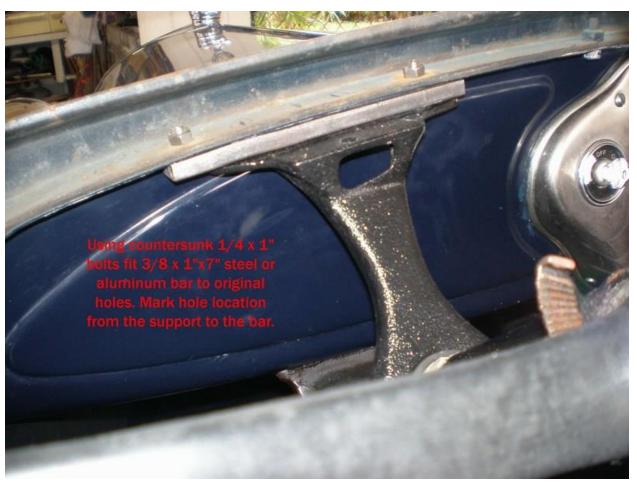
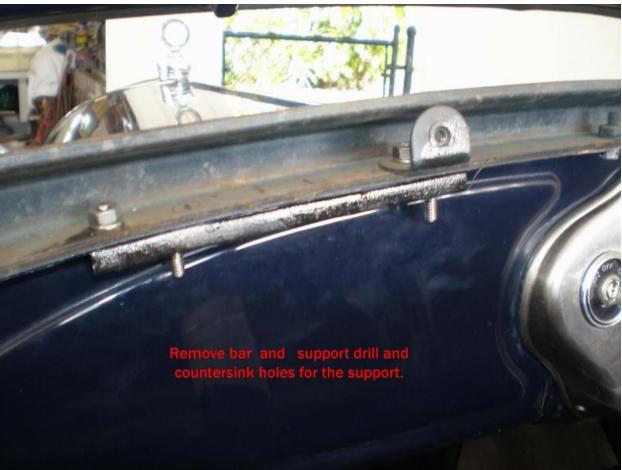
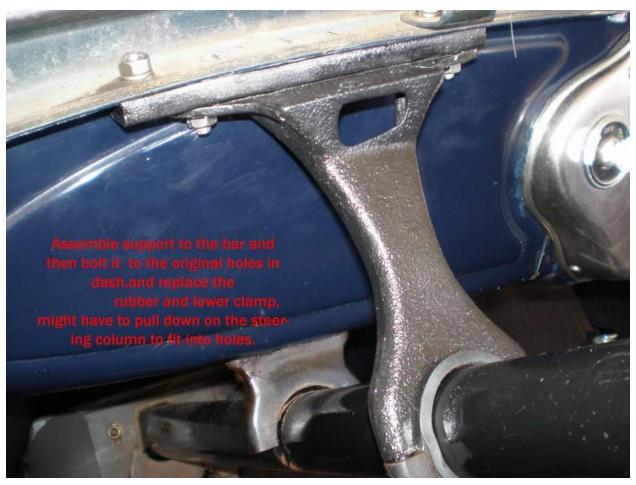
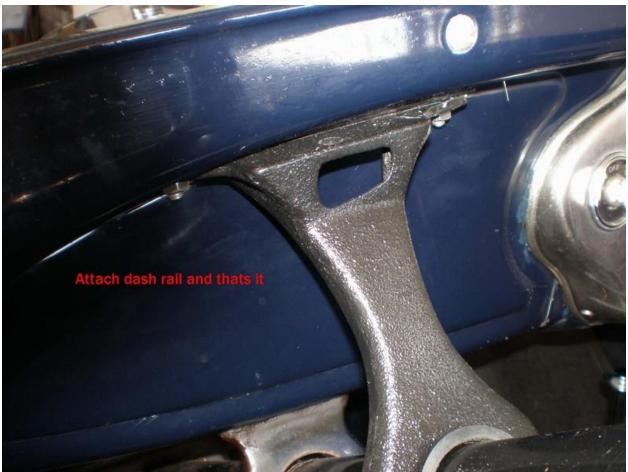
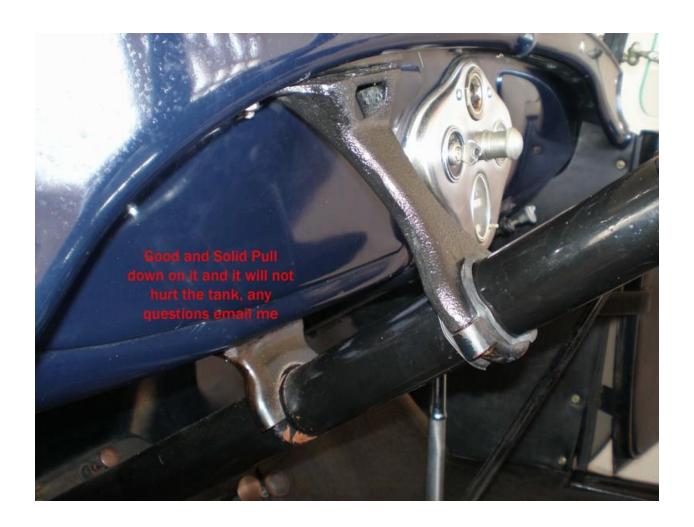
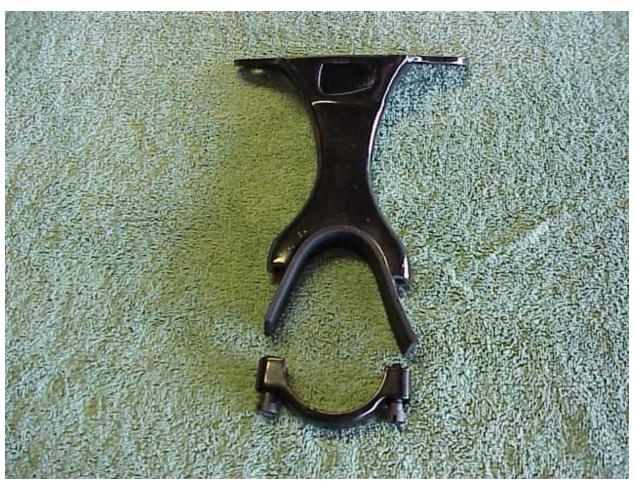
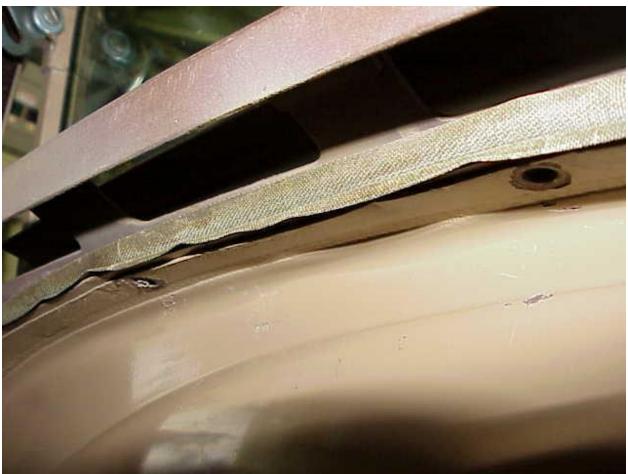
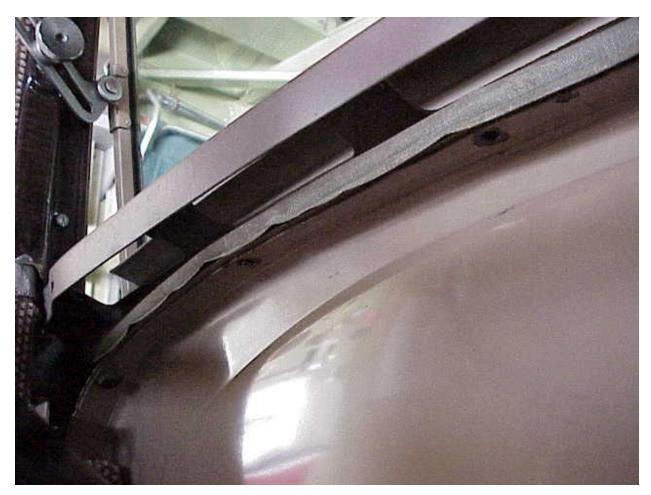
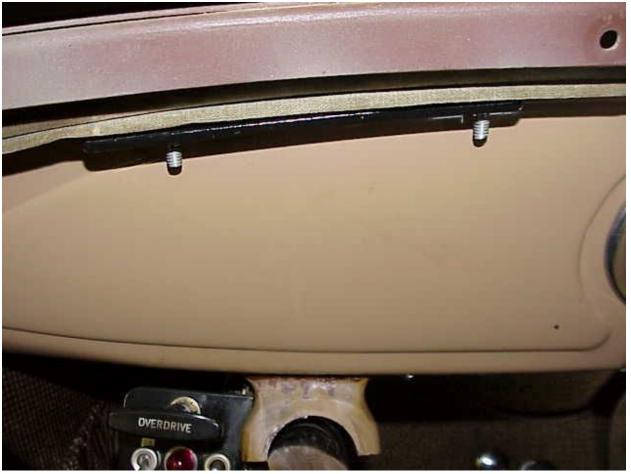
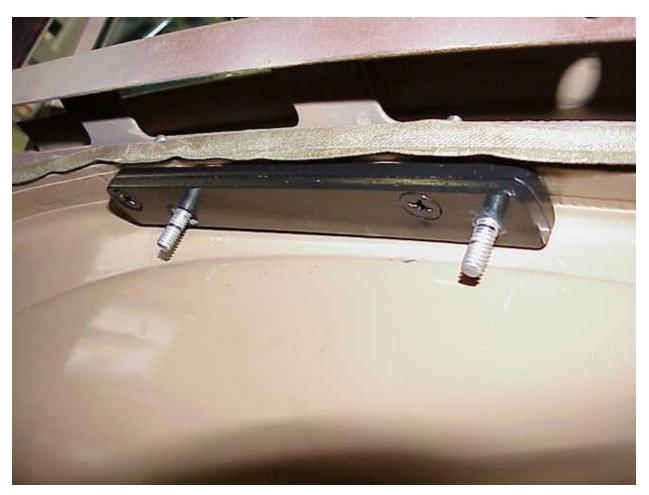
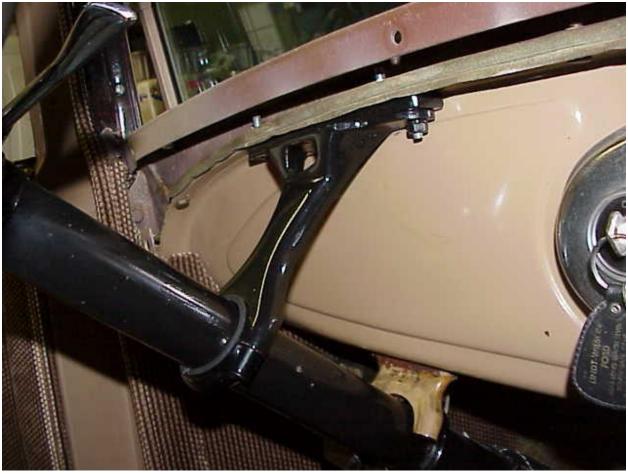
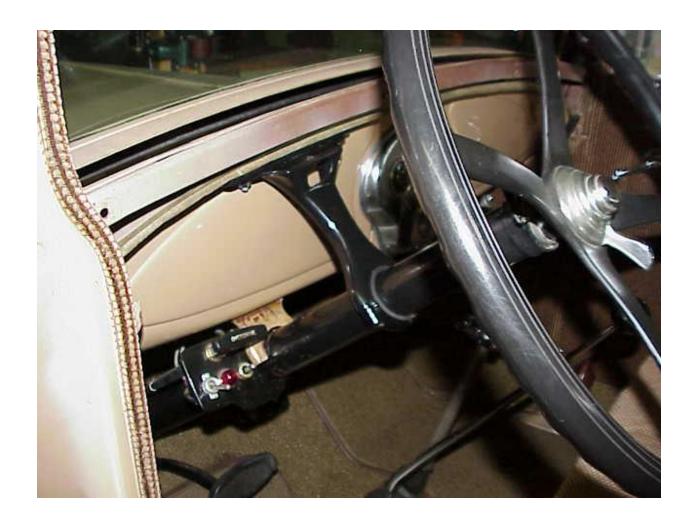
Pictures below show installation on two early Model A's

The following photos of the mounting assembly installed in a 28-29 car were obtained from a posting on the Fordbarn forum a few years ago.

The adapter can be fabricated from either steel or aluminum. It should be one inch wide, seven inches long, and 3\8 inches thick. Four holes are drilled in the adapter. Use four 1\4-20 countersunk bolts, one inch long, along with four nuts and lock washers.

Drill and mount the adapter to the dash rail as shown in the photo with two of the bolts. Mount the later column support to the steering column and mark the adapter where the mounting holes line up. Drill the other two holes in the adapter. Mount the column support to the adapter using the other two bolts.

The existing tank mount can be left in place on the 28-29 cars as the 3/8" adapter will position the steering column just enough so there is clearance all around and no pressure is put on the old mount.
