Borg Warner Repair

by Tom Endy

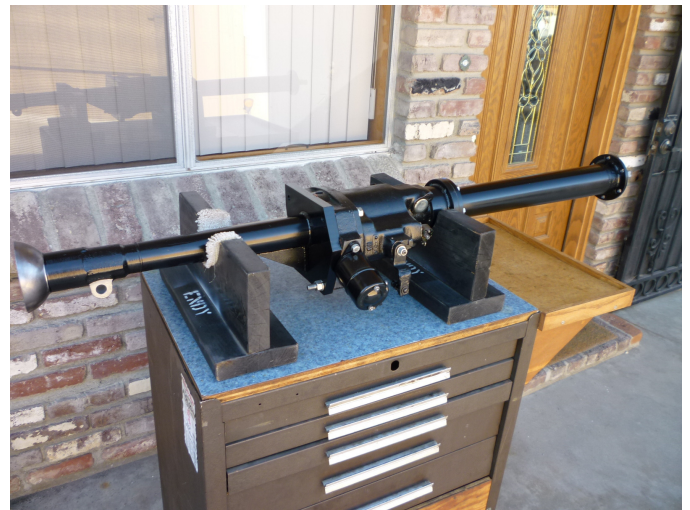
1. This Borg Warner Model A Modification was made from either a Studebaker or Nash with the short housing.

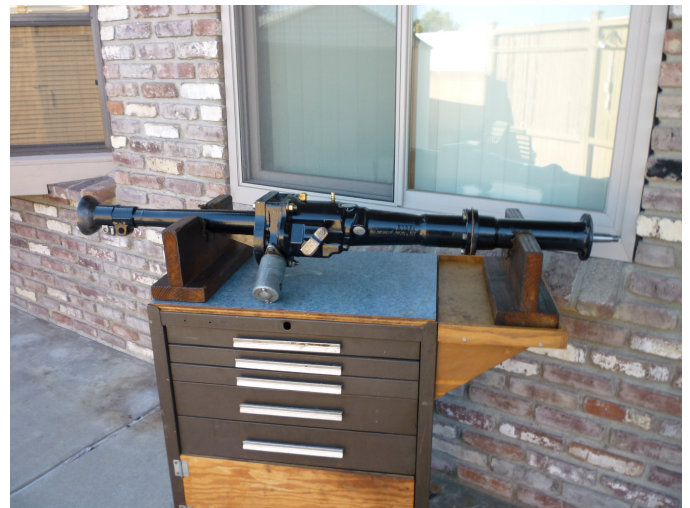
2. This Borg Warner Model A modification was made from a Ford with the long housing. The long housing modifications have a tendency to crack where the aft section is welded to a flange.

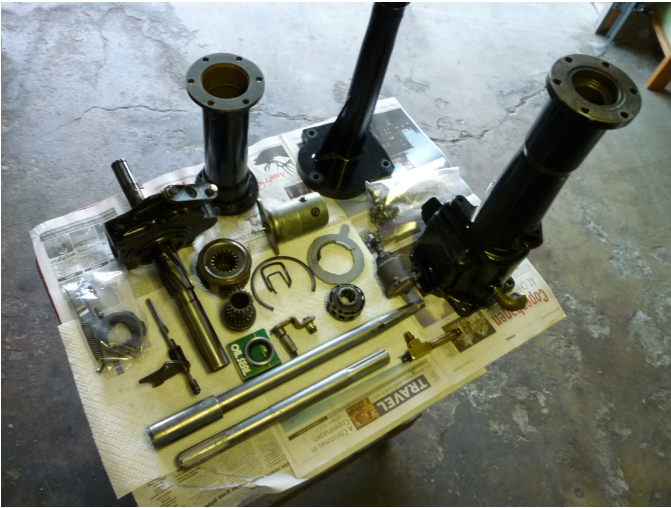
3. A disassembled Borg Warner that has been modified for a Model A. The original configuration is from a "modern" Ford car as it has the "long" housing.

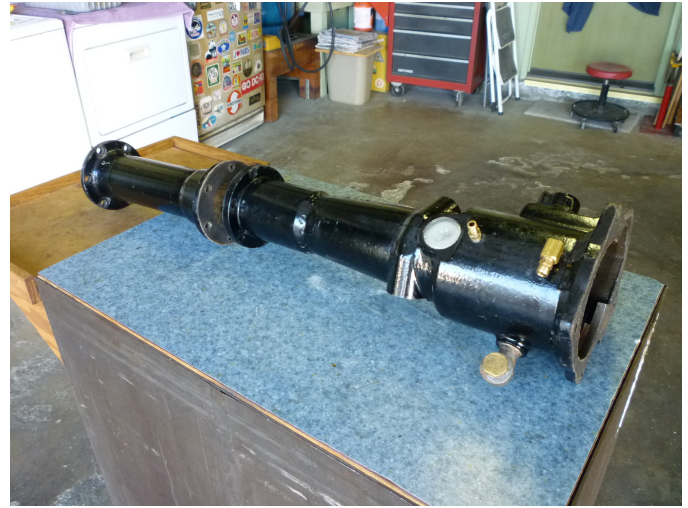
5. The aft section is also taken from the rear section of a Model A torque tube. A mating flange is welded to the aft end of the "long" Ford Borg Warner overdrive housing. When using the Studebaker or Nash overdrives a mating flange can be welded to the aft section of the Model A torque tube and mated directly to the aft end of the overdrive housing.

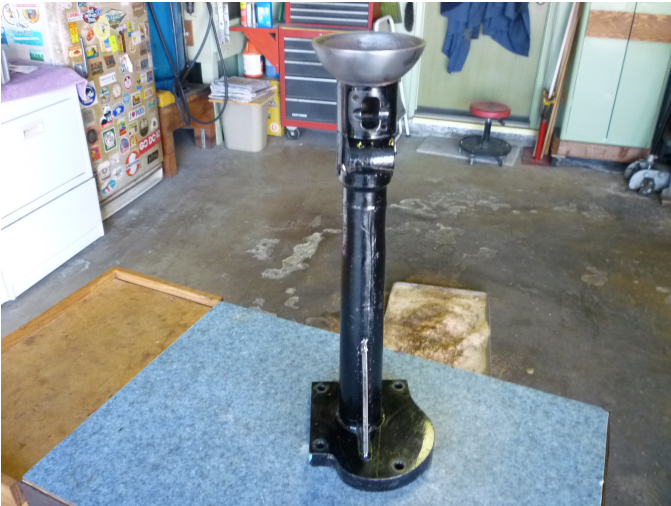
4. The front section is taken from a Model A torque tube and is sectioned and welded onto a mounting flange that mates to the front of the Borg Warner overdrive housing.

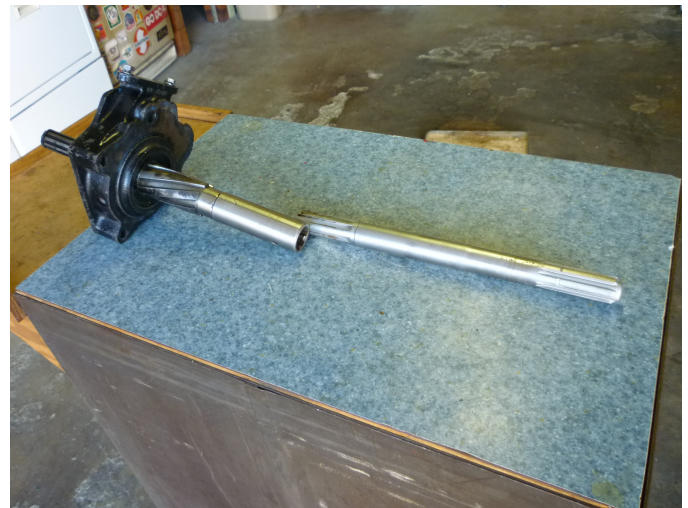
6. The input shaft (at right) is sectioned from a Model A drive shaft and a spline is machined onto the end that mates with a spline coupler that has been pinned and welded to the input shaft (at left) of the Borg Warner overdrive.

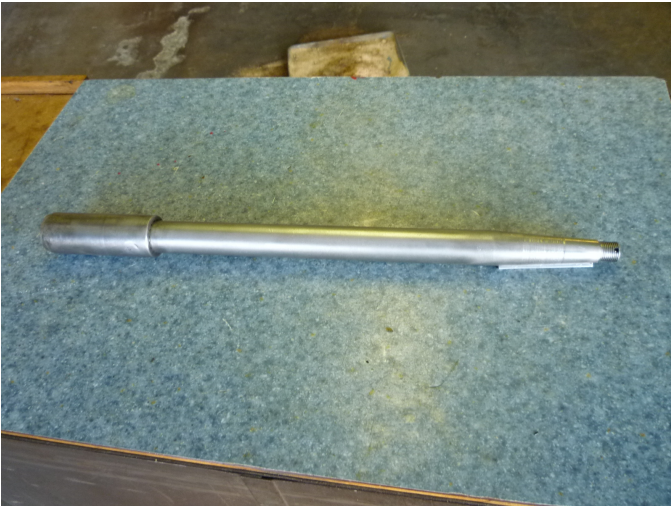
7. The output shaft (also known as a stub shaft) has also been sectioned from a Model A drive shaft and has had a spline machined onto the end. A spline coupler has been pinned and welded onto it. The spline coupler mates with the splines on the output shaft of the Borg Warner overdrive. Some type of oil seal is incorporated with the output shaft. There are several variations of engineered methods, all of which leave something to be desired.

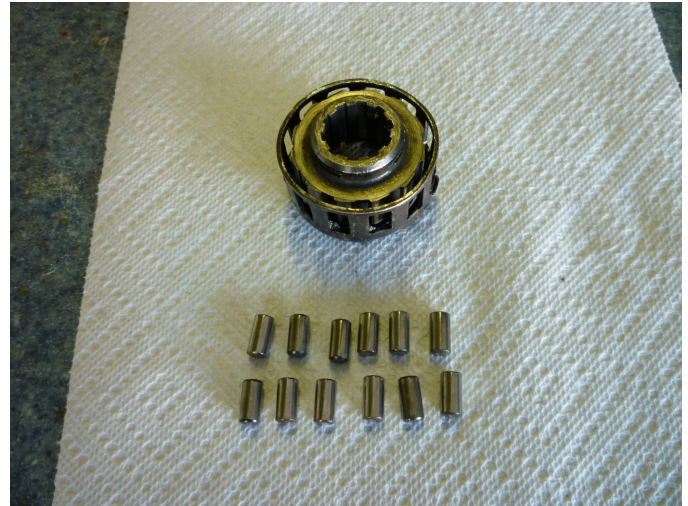
9. The over-run clutch pack: There are 12 individual roller elements in every Borg Warner. Whenever you take one apart the rollers fall out of the pack. It is imperative that you find and account for all 12. The rollers are installed in each of the 12 slots in the pack. The roller elements are held in place with an application of Vaseline while the pack is held in a vertical position. Installing the clutch pack is a tricky business.

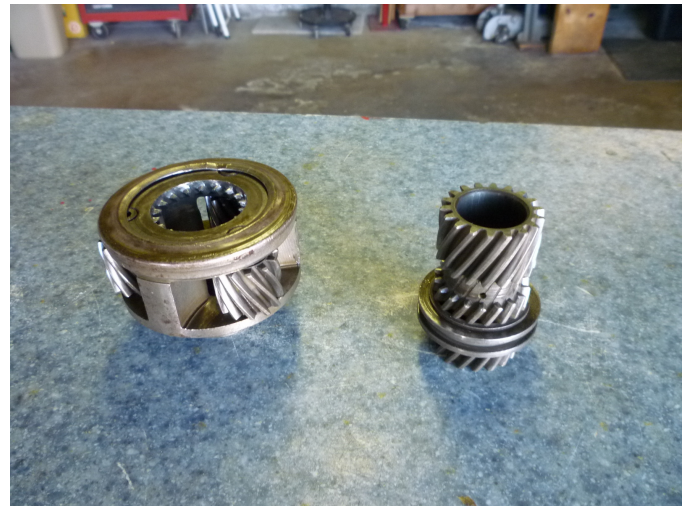
10. The sun gear and the three planetary gears: The sun gear at right installs into the planetary with the short section of gear below the shifting groove installed into the opening of the planetary section at left. These two parts are usually the first things to fail when the overdrive is starved for oil.

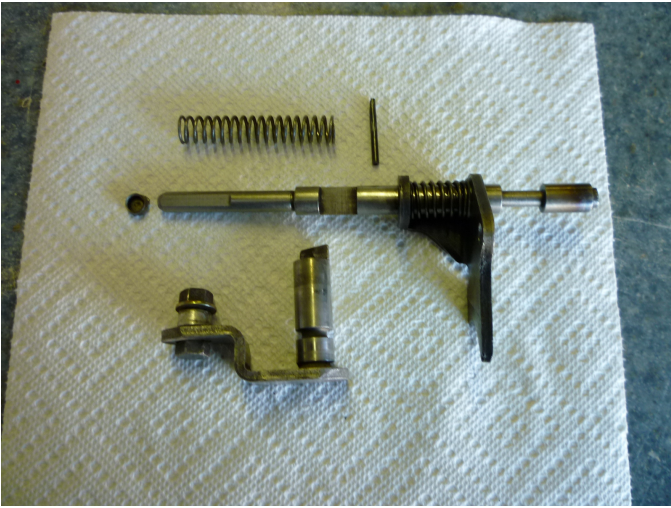
11. The shifting mechanism: The lever at right is inside the housing and fits into the groove collar on the sun gear to enable it to be shifted fore and aft. The lever at the bottom is outside the housing and has a pull cable attached to it. The driver operates the cable to shift in and out of the free wheeling portion of the overdrive engaging sequence. The pin at top right is driven into a hole in the outside of the housing to retain the outside shifting mechanism. The little cap at left is inserted into a hole in the housing. It is removed to enable a mechanic to rotate and engage the inside shifting lever during assembly.

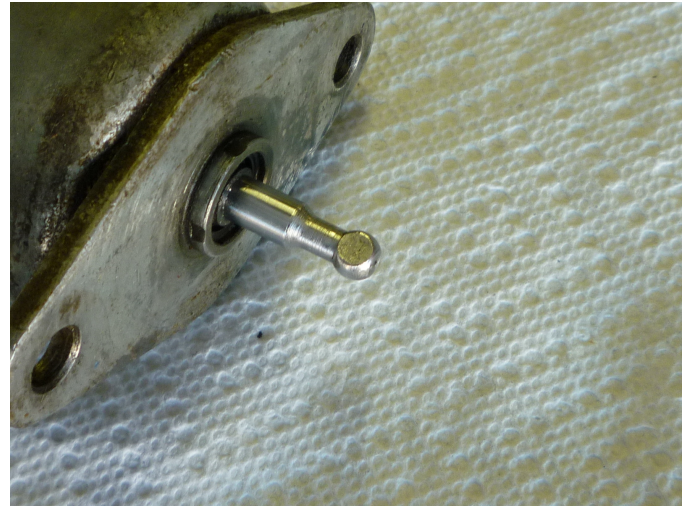
13. The end of the solenoid shaft has a ball on the end with two sides machined flat. The solenoid is installed by slipping the ball into the circular hole in the pawl and rotating the solenoid housing 90 degrees to lock it in place before installing the two mounting bolts.

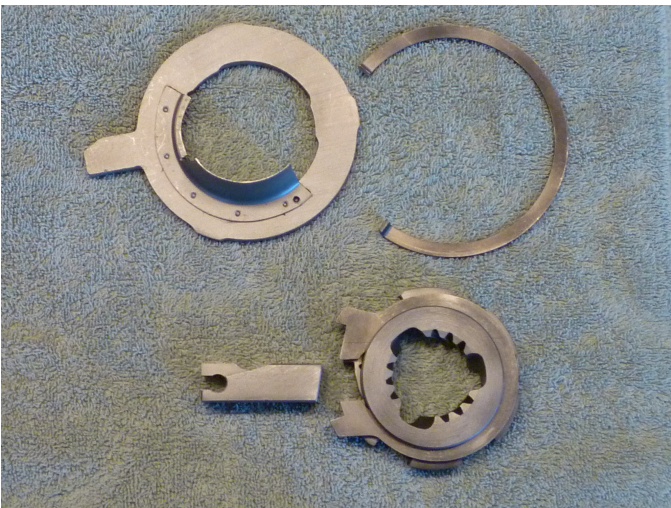
12. The blocking mechanism: These parts make up the solenoid engaging mechanism that is part of the overdrive shifting sequence. The pawl at lower left moves in and out with solenoid action and engages the slots in the blocking mechanism. A round ball on the end of the solenoid shaft fits inside the circular hole in the left end of the pawl.

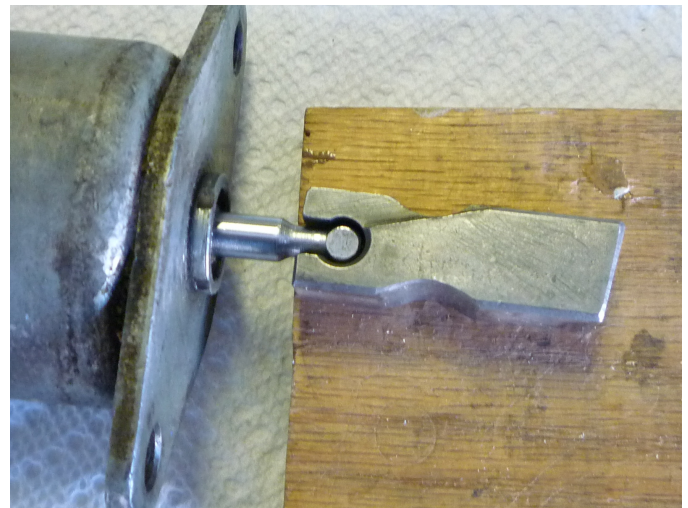
14. The solenoid ball is shown inserted into the pawl. It is important to install the solenoid correctly in order for the overdrive to work. Incorrect installation will prevent the solenoid from fully actuating and the internal heavy current switch contacts will not open and it will cause the solenoid to overheat and fail.

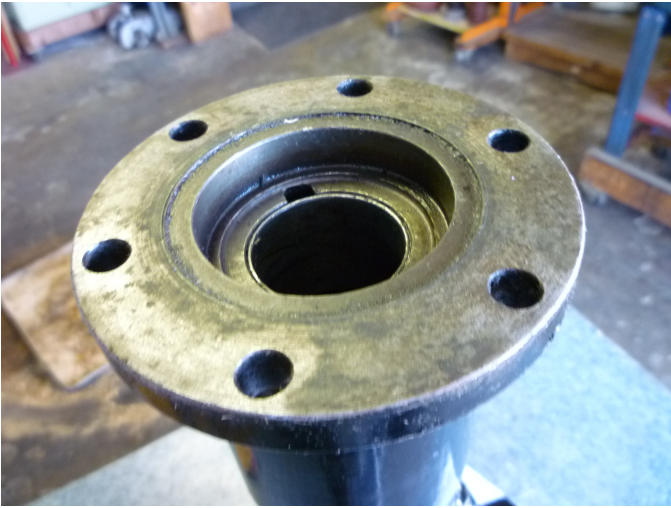
15. The output section of a Borg Warner overdrive modified for a Model A incorporates some type of an oil seal. This particular modification uses a large automotive seal that is inserted into the recess of the flange.

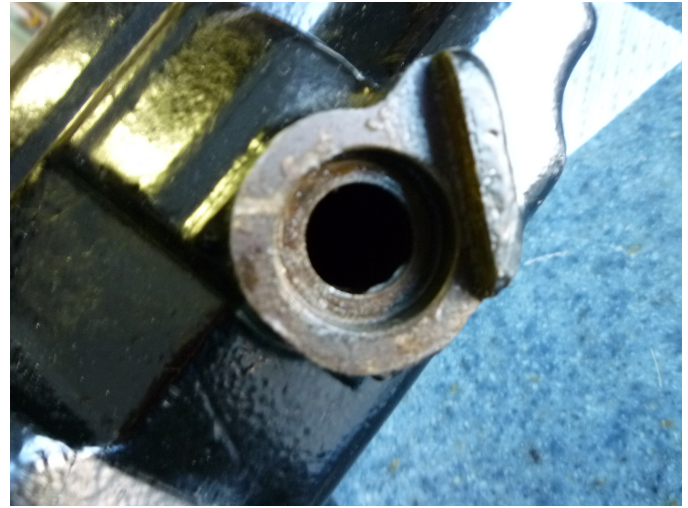
17. The shifting lever boss is shown with the seal removed.

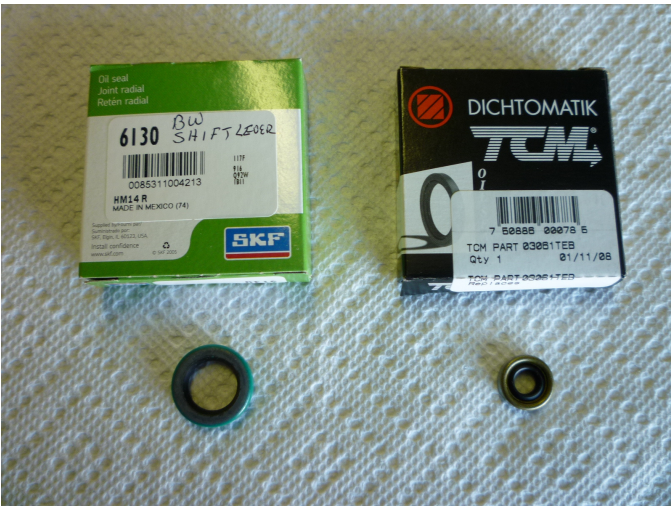
16. Two other seals are also important to control oil leakage. The one at left is inserted into the shift lever boss. The one at right is inserted into the solenoid shaft boss. Both seals are available from a bearing supply house. It is prudent to change both when overhauling a Borg Warner overdrive.

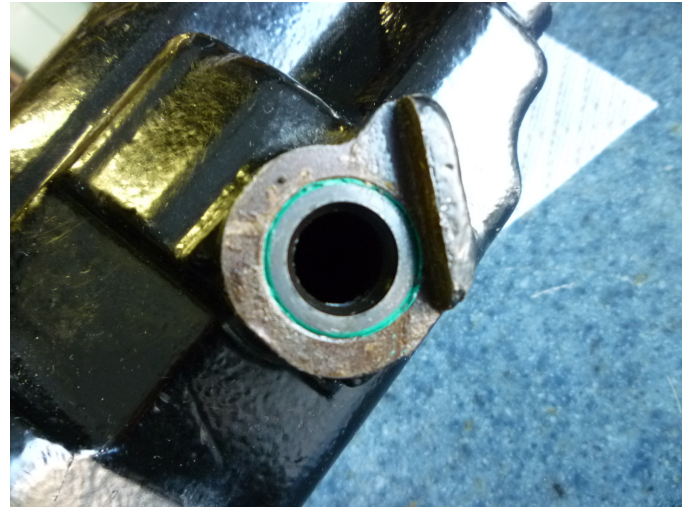
18. The shifting lever boss is shown with a new seal installed.

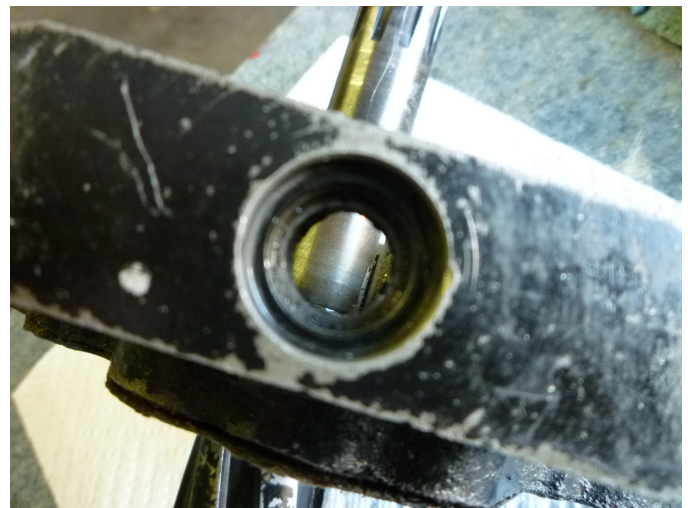
19. The solenoid boss is shown with the seal removed.

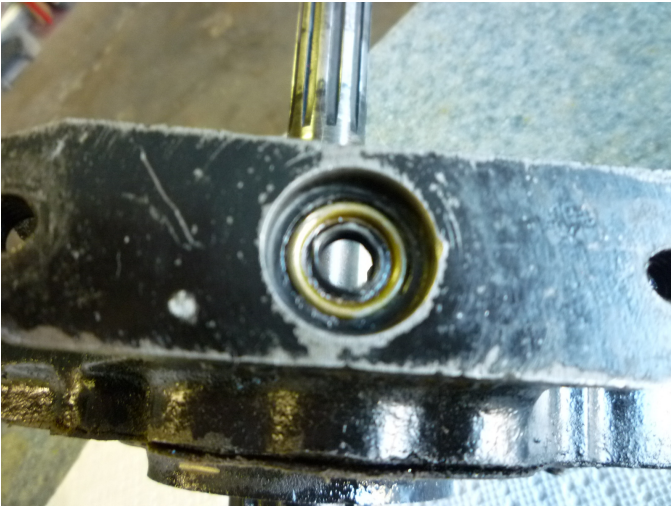
20. The solenoid boss is shown with a new seal installed.

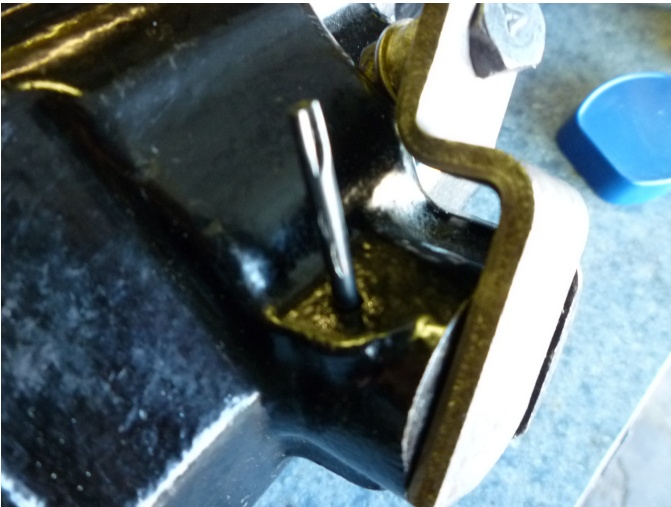
21. The locking pin is shown that retains the outside shifting lever.

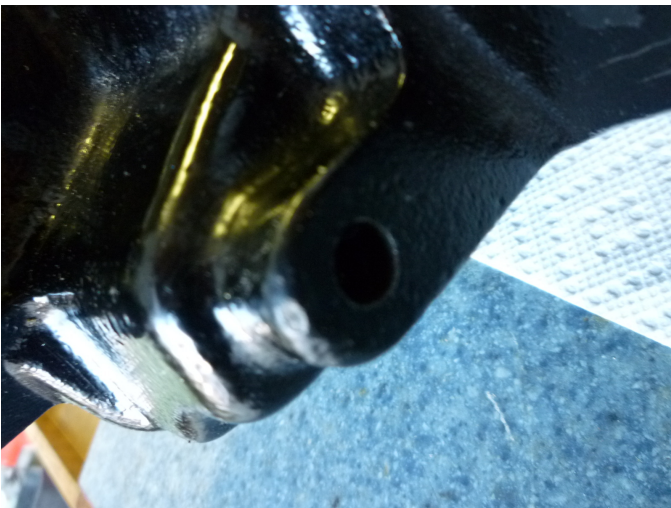
22. The hole shown in the housing is where the small plug is inserted after the inside shifting lever is rotated to engage the outside shifting lever during assembly.

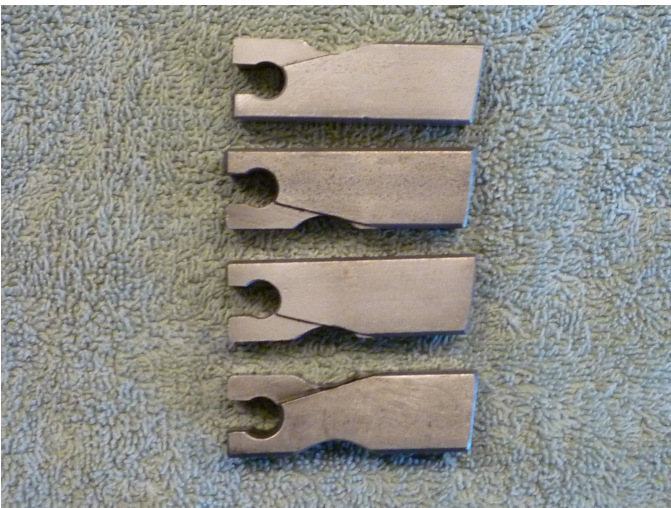
There are several pawl variations. The two in the center are identical. The top and bottom pawls are different from the center two. The secret of installation is the machined relief should always be facing up and the angle at the right end of each one is oriented as shown. This is the one part in the Borg Warner that is easy to install incorrectly.

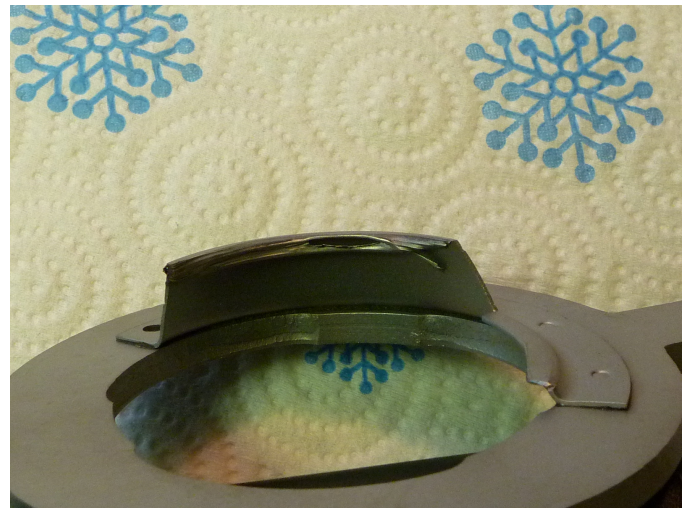
27. An example of a deformed oil deflector: This was the cause of the failure in the overdrive undergoing repair in these series of photos.

26. The blocking plate is installed and is held in place with a large snap ring. The sun gear, planetary gears, and over-run clutch pack are assembled on top of the blocking assembly. Note the oil deflector standing vertical at the lower right on top of the blocking plate. The Motors Manuals warn that they can easily become distorted and jam the sun gear. The result is the overdrive will be stuck either in overdrive or out of overdrive. If stuck in overdrive you will not be able to back up.

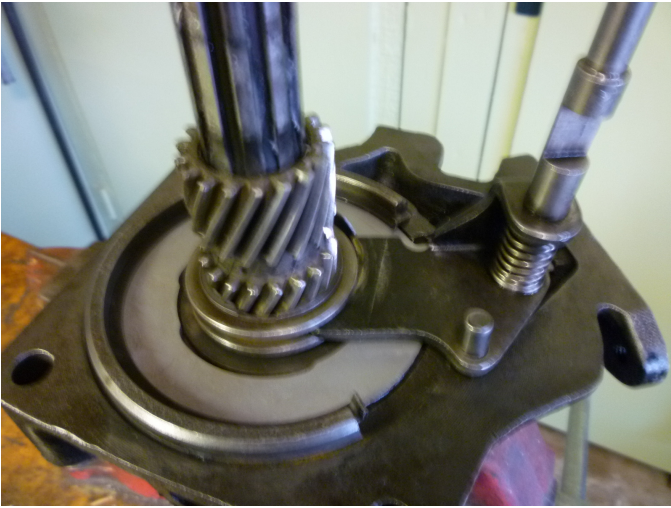
28. The sun gear is installed with the long portion of the gear up. The inside shifting lever is installed with the shifting arm inserted into the groove of the sun gear.

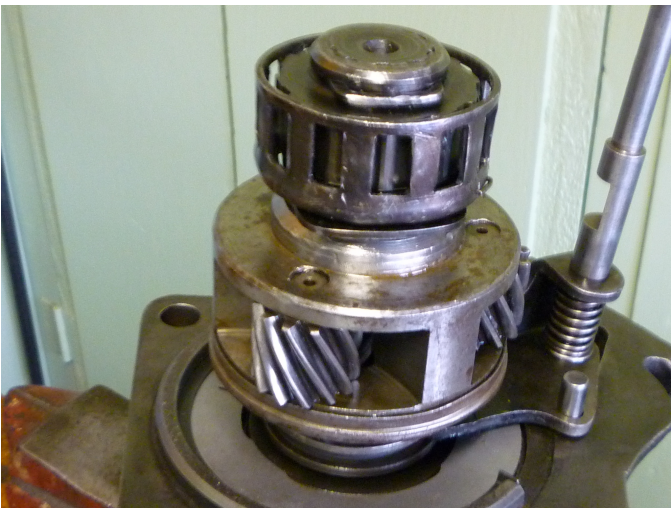
29. The planetary gear assembly is inserted onto the sun gear and the clutch pack is installed on top. The bottom of the clutch pack is held onto the planetary gear assembly with a large U-shape snap ring. The top of the clutch pack is held onto the output shaft with a smaller U-shape snap ring.

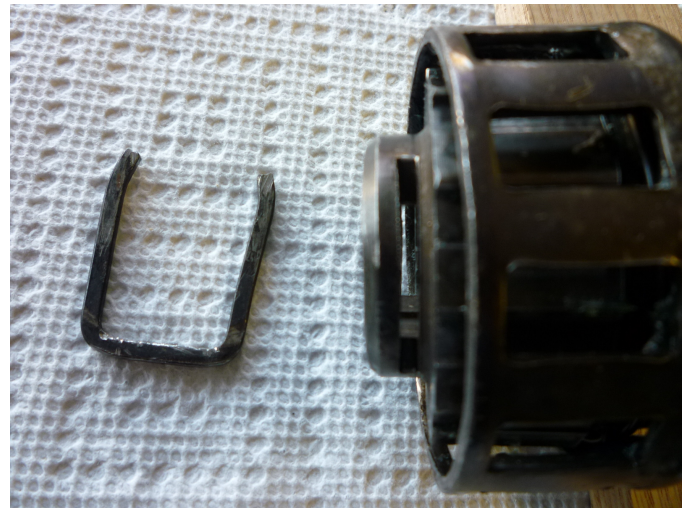
31. The top of the clutch pack is held onto the output shaft with a U-shaped snap ring. The snap ring fits into the slots of the clutch pack and into a groove on the end of the output shaft. It is important that both of these U-shape snap rings fit snugly in place. Often they are found somewhat spread and could easily become disengaged. Squeeze the ends closer together in the jaws of a bench vice.

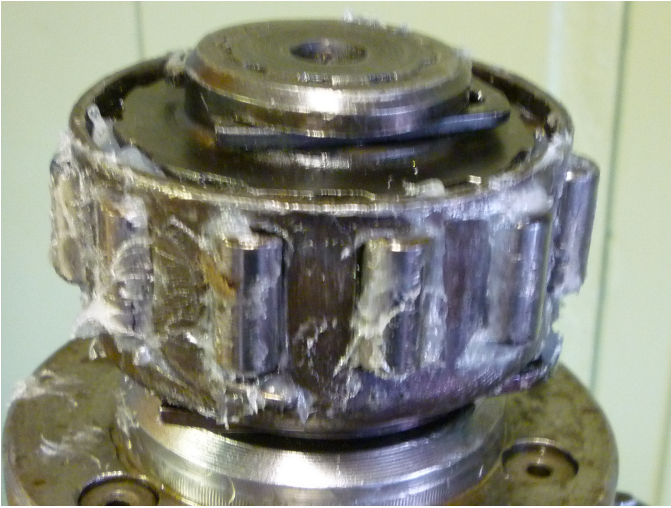
32. The 12 roller elements are held in the 12 slots of the clutch pack with a liberal coating of Vaseline. Some people place a rubber band around the elements and leave it in place during the assembly. I don't subscribe to this practice. Broken pieces of rubber band floating around inside could be detrimental.

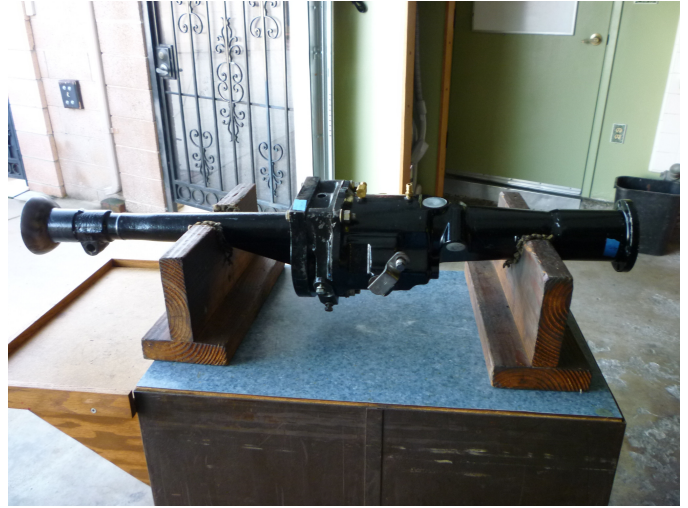
34. The front section is then installed and the input shaft inserted. The standard Model A front seal, race and roller bearing are then installed along with the mechanism for the speedometer drive.

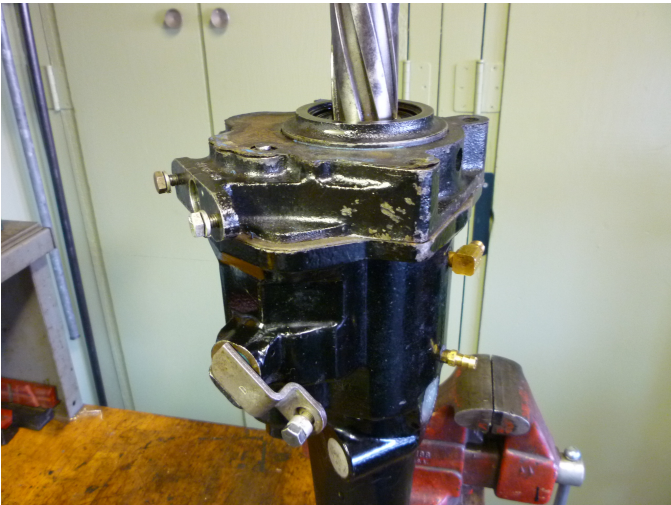
33. The forward section of the overdrive is slid into place over the clutch pack. The assembly must be held vertical as the two sections are slid together. Care must be taken so as not to dislodge any of the 12 roller elements. The rod on the internal shifter has to be slid into a recess at the same time. The spring is first inserted inside the housing before assembly. The outside shifting lever has to be pulled outward to allow the two sections to go together. The shaft of the inside shifter is then rotated through the hole in the end of the housing to engage the slot in the inner shifter with the cam on the inside of the outer shifter. The retaining pin is then driven into place and the plug inserted into the end of the housing.
