# The Multiple Disk Clutch

by Tom Endy

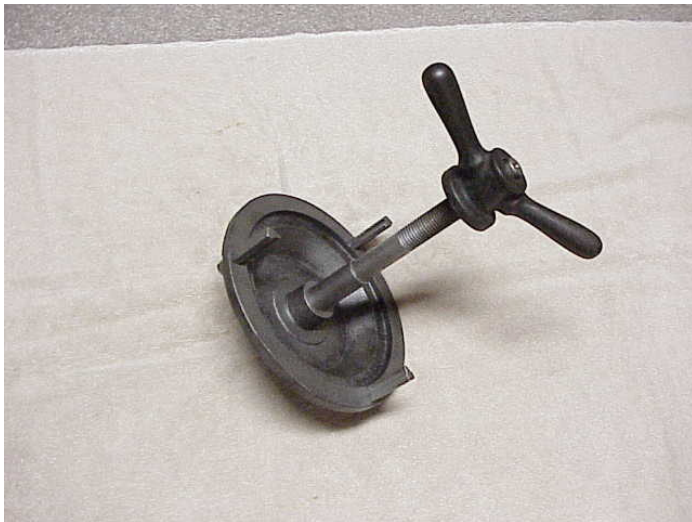
**The K. R. Wilson alignment tool**

It is essential to have either the K. R. Wilson alignment tool shown on page 223 of the service bulletin, or a reasonable substitute. You can easily get the multiple disk clutch assembly apart using a shop press, and you can also put it back together using a shop press. However, unless you concoct a means of lining up the outer teeth of each of the four driving disks that has the composite lining material on them, you will never get the clutch installed in the flywheel. The alignment tool, or a shop press, is needed to compress yet another of Henry's "killer" springs. I was fortunate enough to acquire the loan of a K. R. Wilson alignment tool from a fellow Model A'er who is a 1928 purest and has a multiple disk clutch installed in his car.

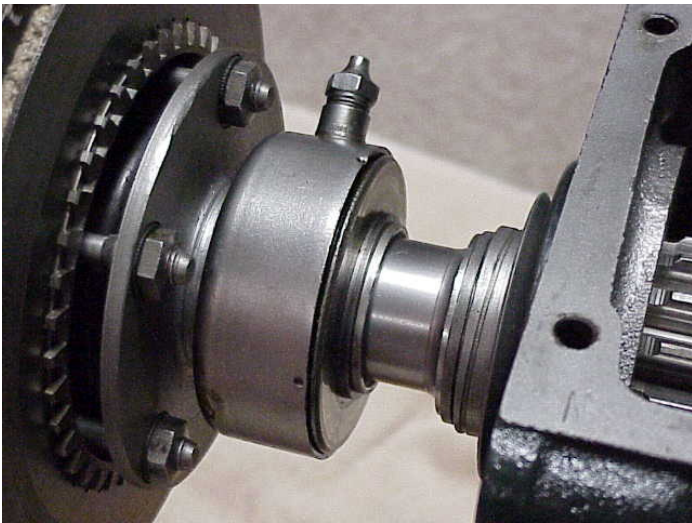
The multiple disk clutch used a completely different throw-out bearing than the one used with the single disk clutch. There are no new replacements; you have to locate an original. Surprisingly, most of the originals that I have seen were perfectly serviceable. These early throw-out bearings were better designed and better made. The grease fitting is mounted right on the bearing, and spins with the bearing. When you grease one of these throw-out bearings you are pumping grease directly into the bearing itself. When you grease a throw-out bearing on a single disk clutch, you are only applying grease to the slider part of the front bearing retainer, you are not greasing the bearing itself. That's probably why they eventually fail. As soon as the factory applied grease is gone, so is the bearing. The multiple disk throw-out bearing is mounted right on the clutch assembly and mounts backwards to the single disk throw-out bearing. The smooth machined surface of the bearing is pushed on by the fork located in the bell housing.

**The throw-out bearing and extra oil baffle**

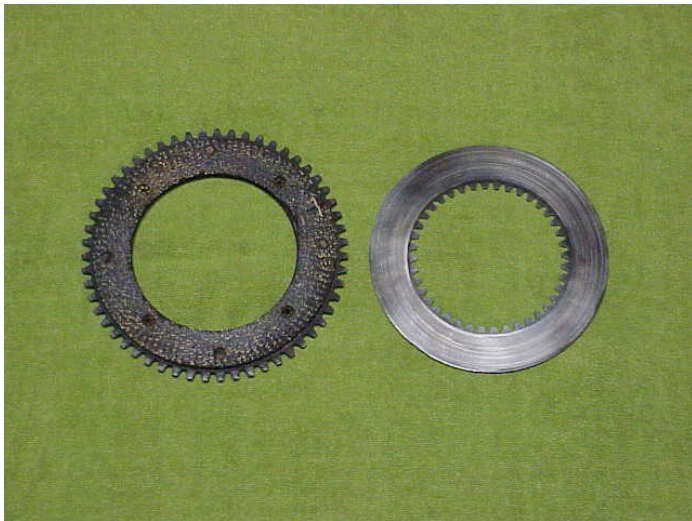
The series of disks that make up a multiple disk clutch are divided into two categories, the driving disks, and the driven disks. There are four driving disks; each has outer teeth that mesh with the inside teeth machined into the flywheel. Both sides of the driving disks have a composite clutch material riveted on. The material is the same as used on a single disk clutch. The design provides eight sides of composite clutch surface. The driven disks are made of saw blade material and in fact look much like a circular saw blade. There are five driven disks. The inside diameter of these disks have teeth that mesh with mating teeth machined on the clutch assembly drum that is attached to the input shaft of the transmission. The driving and driven disks are alternated in the assembly providing a metal surface for each side of the eight composite surfaces to rub against. Henry's killer spring tightly sandwiches them together whenever the clutch is engaged.

**Driving disk (left) driven disk (right)**

The composite material used on the driving disks is the same as that used on single disk clutches and any clutch rebuilding facility will have the capability of replacing the composite material on the driving disks. However, the cost is significant, as the clutch material has to be applied to both sides of four disks. On the other hand, many of the disks, in their original condition, are still serviceable. As long as the composite material is not torn or worn off, or hopelessly soaked in oil, they can be reused. I found that by bead blasting the composite surface, along with the rest of the disk, any glaze residing on the surface could easily be removed.

The saw blade material that makes up these disks can also be cleaned up with a bead blaster. Inspect them for grooves in the surface. If they are not too bad they can be reused. I know of no way to resurface these disks. Use the best you can find.

Inspect the shape of the teeth on both the driving and the driven disks. The teeth should be flat across the top giving them something of a square look. Disks that have seen a lot of service will tend to wear the teeth such that they become pointed. Use the best you can find.

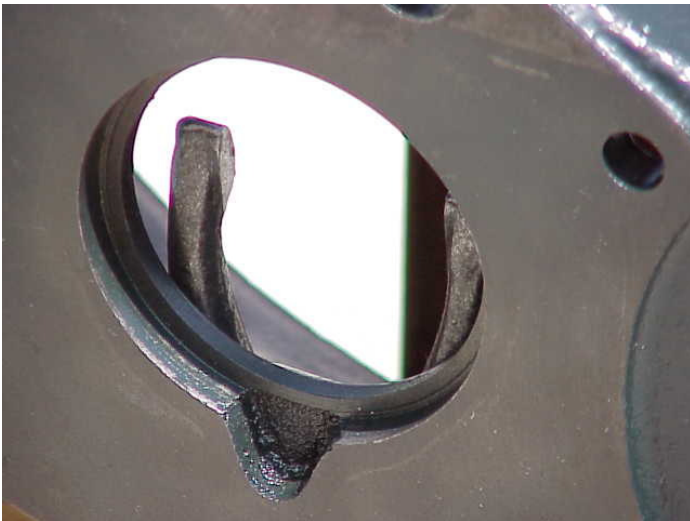
**Oil baffle and snap ring mounts in recess**

The bell housing used with the multiple disk clutch is slightly different than the one used with the single disk clutch. There is another oil baffle (A7047-R) retained with a large snap ring (A7046-R) that attaches to the transmission side of the bell housing mounting surface. The bell housing must be bolted to the transmission housing before the multiple disk clutch assembly is mounted onto the transmission input shaft. To install the bell housing onto the back of the flywheel housing it is necessary to engage the external teeth of the four driving disks of the clutch with the internal teeth of the flywheel. This is where you hope the K. R. Wilson alignment tool was used correctly. The pedal shaft used with this early bell housing is smaller in diameter than those used with the single disk clutch. Early pedals with a matching diameter must be used with this bell housing. The fork used to push against the throw-out bearing is slightly longer than the one used with the single disk clutch. The cover plate that provides access to grease the throw-out bearing is also different (part number A7518-AR). It is smaller, bent at an angle, and has no vent holes.

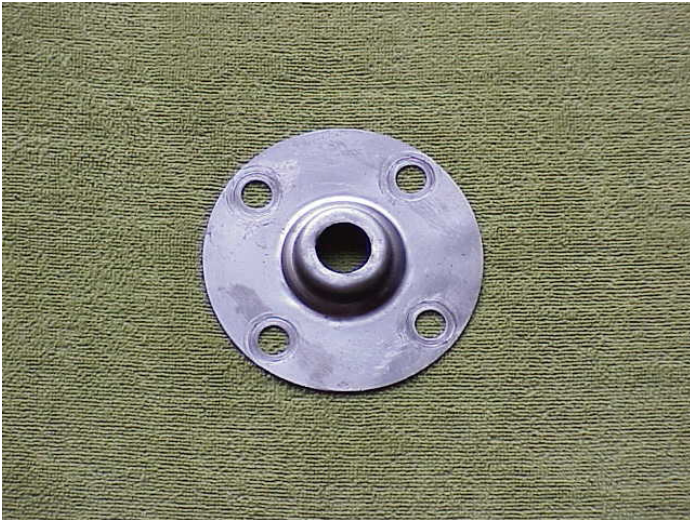
**The A7609-AR Retainer (felt not shown)**

The flywheel used with the multiple disk clutch is completely different from the one used with the single disk clutch. The distinguishing feature is the internal teeth machined into the flywheel to accept the teeth of the driving disks. It is important that the flywheel teeth be clean and in good condition. Flywheels that have seen a lot of service will tend to have grooves worn into one side of the internal teeth caused by the mating teeth on the driving disks. There is no way to repair it, so select the best flywheel for use that you can find. The pilot bearing that is mounted in the center of the flywheel is held in place with a retainer plate (A7609-AR), and includes a felt insert (A7608-R).

A metal retainer with felt is installed on the flywheel just behind the pilot bearing. It is shown in the service bulletin of February 1928 on page 221, figure 448 and referred to as "clutch pilot bearing felt and retainer". The service bulletin does not explain it's purpose, but I suspect it is to prevent oil from the engine from reaching the clutch. It may also provide protection from dirt migrating into the pilot bearing.

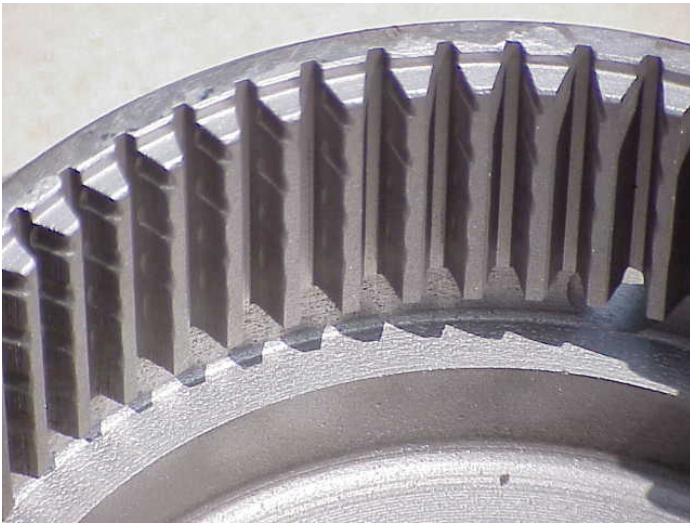
**Notches worn in the flywheel**

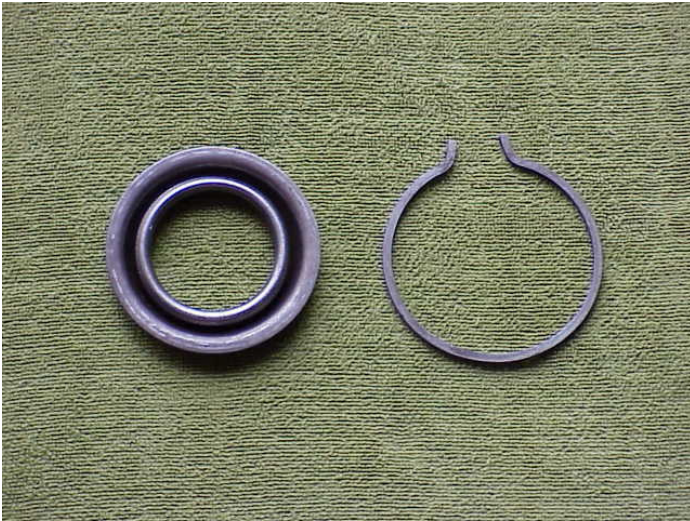
**A7047-R oil baffle and A7046-R snap ring**
